Annual report of Low-energy house performance July 2009 to June 2010

LOW-ENERGY HOUSE IN SISIMIUT

Annual report of Low-energy house performance
July 2009 to June 2010

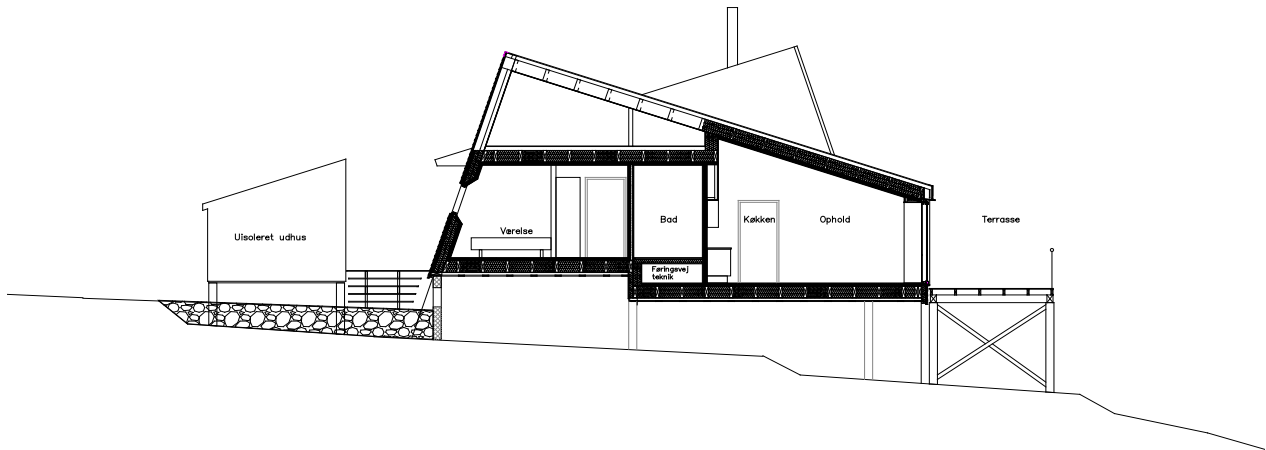
Figure 1 Low-energy house layout and cross section. The house is divided in two apartments, one serves as accommodation for a family and the other one as exhibition / guest house.

Figure 1 shows the floor plan of the low-energy house and a vertical cross section through one of the apartments.

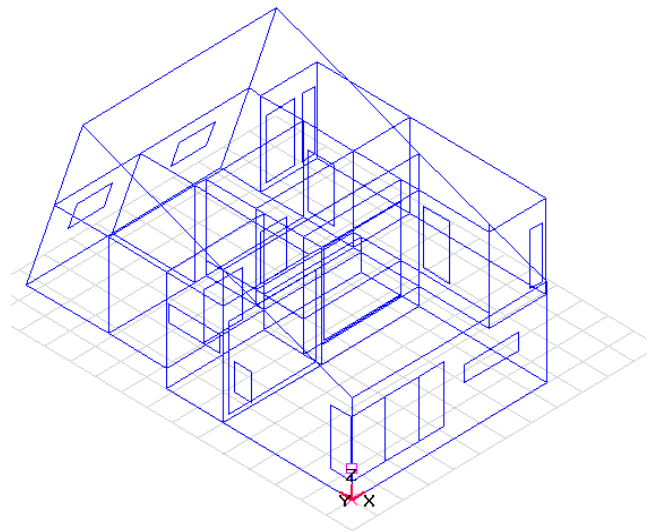
Figure 2 Simulated model from BSim

A simulation model of half of the low-energy house was created in the building energy analysis program BSim [5]. For the simulation of ambient temperature the annual weather data of Sisimiut (test reference year - TRY) was used. Figure 2 shows the simulation model BSim. The simulation model is described in detail in [6].

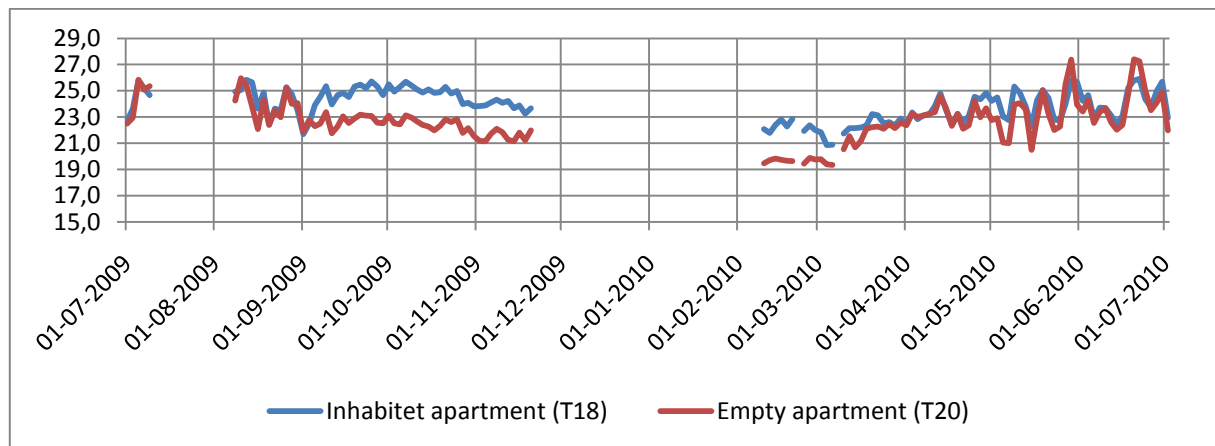
Figure 4 Measured air temperature in kitchens/living rooms from July 2009 to June 2010

The average temperature in the inhabited apartment has been rather high. Also the measurements from previous years showed the same phenomena. It is probably caused by the different demands of the people living in the arctic. However it might also be caused by the improper control of the heating and ventilation system where in case that the temperature in the space is above the set point, the after heater in the ventilation system should heat the air up to lower temperature.

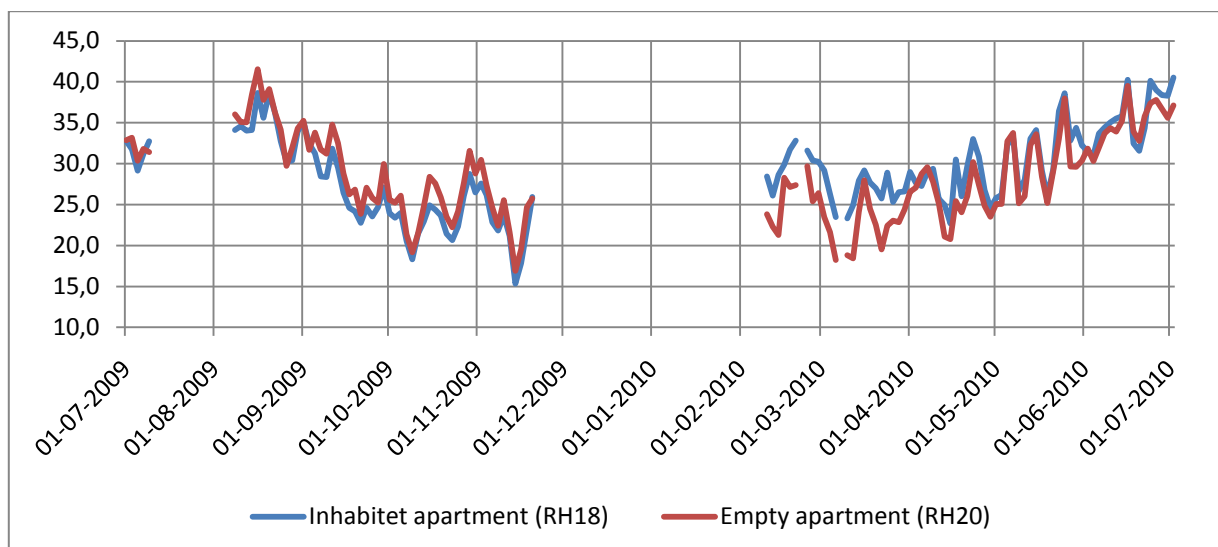
Figure 5 Measured relative humidity in kitchens/living rooms from July 2009 to June 2010

As expected, the relative humidity is seen to be lower than normal for Danish conditions.

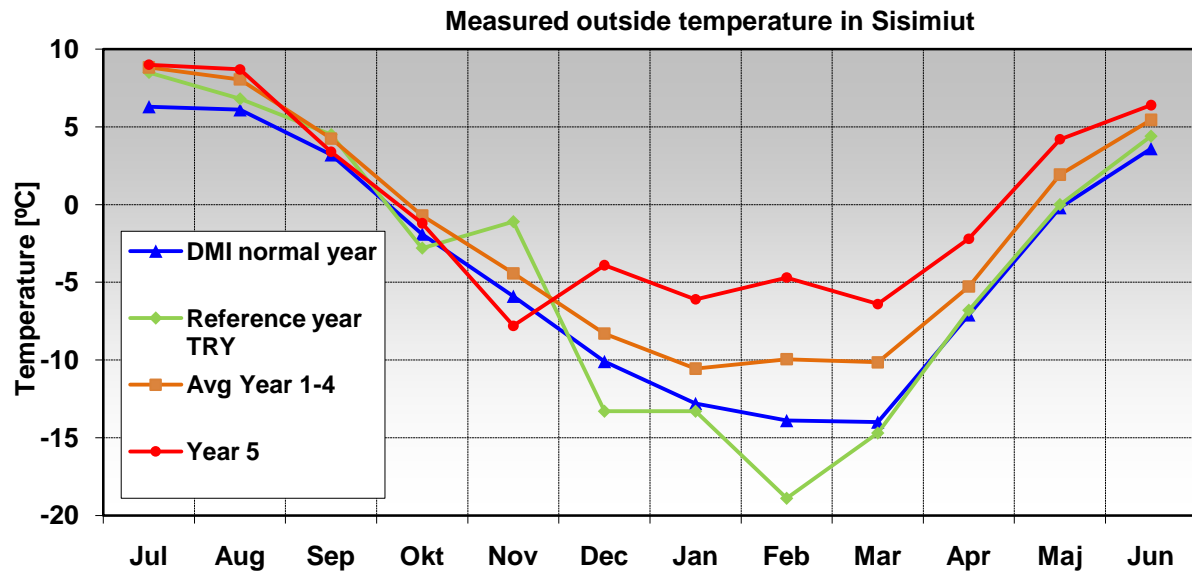
Figure 6 Measured outside temperature in Sisimiut. DMI normal year from www.dmi.dk. Data for reference year (TRY) from ASIAQ.

The temperatures of the TRY together with the real temperatures during last five years are presented in Figure 6.

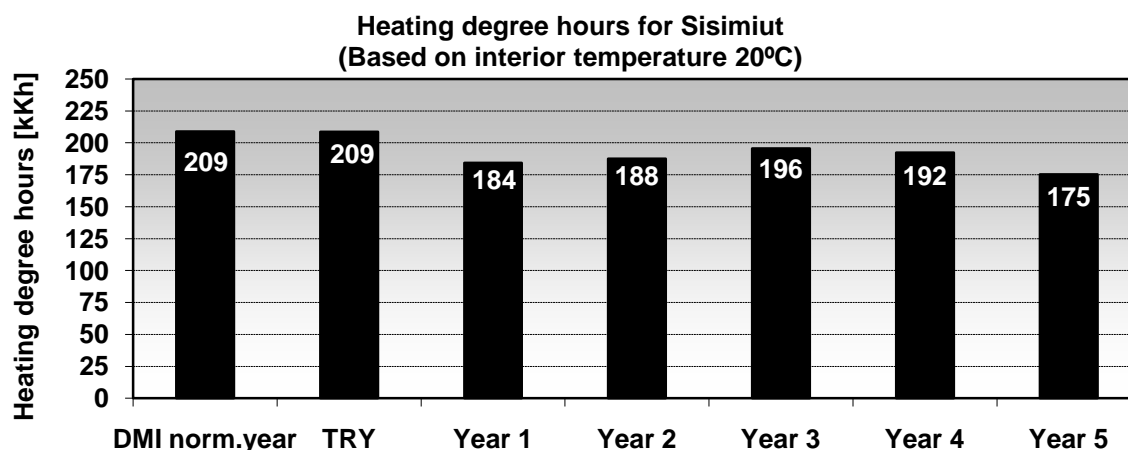
Figure 7 Calculated heating degree hours with interior temperature 20°C.

Compared to the first four years of operation and to TRY data, the year 5 was milder. The number of heating degree hours in the year 5 was 10% lower than the coldest year 3 and 16% lower than the TRY.

Figure 7 shows the estimated total annual number of degree hours. These values are compared with DMI's normal year and reference year (TRY).

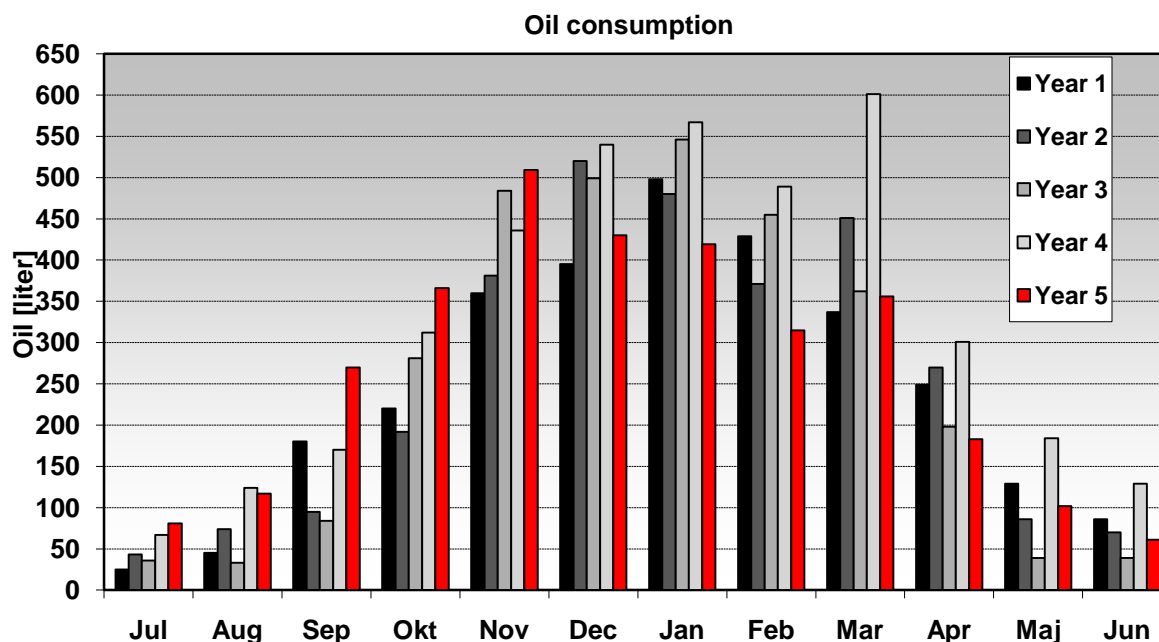
Figure 8 Oil consumption throughout the years

Figure 8 shows the measured oil consumption spread over the months of the year.

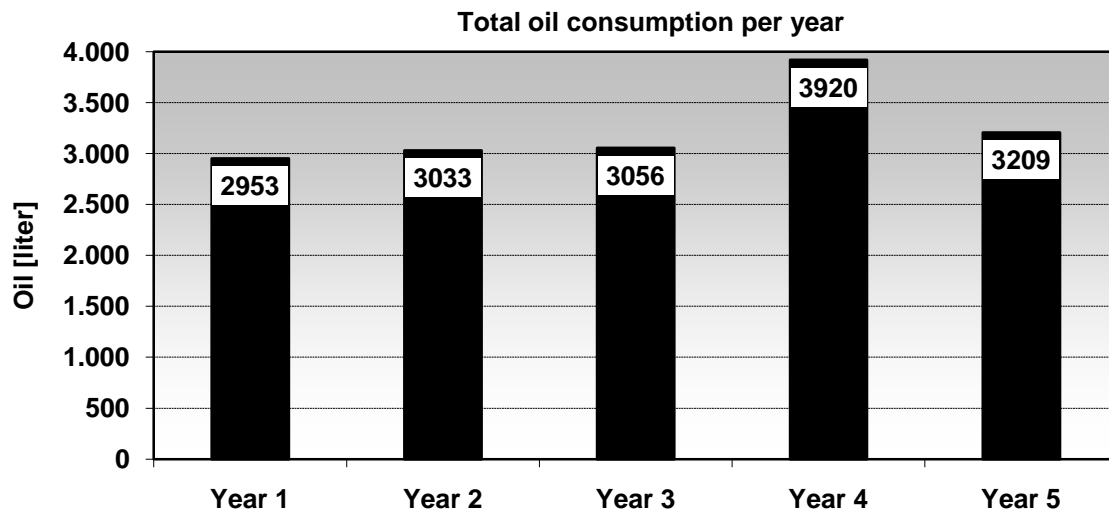
Figure 9 Annual oil consumption

The oil consumption has decreased by 20% when compared to year 4. Part of this savings is caused by milder winter (app. 50%) and the rest is probably caused by fixing the broken damper in the heat exchanger in December 2009. After the damper has started working, the efficiency of the heat exchanger has increased¹.

Figure 9 shows the total annual oil consumption.

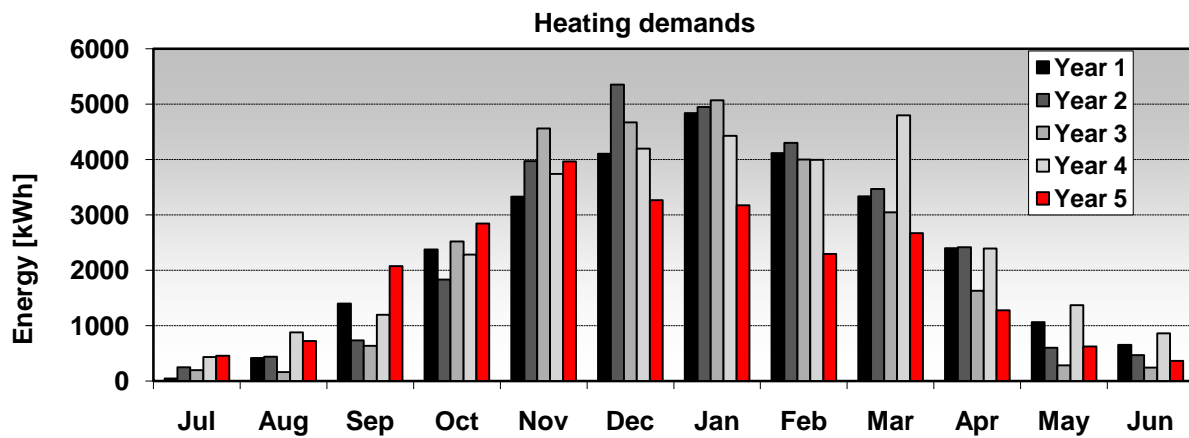
Figure 10 Heat distribution through the years

Figure 10 shows the measured heating demands spread over the months throughout measured years. Heating is excl. domestic hot water.

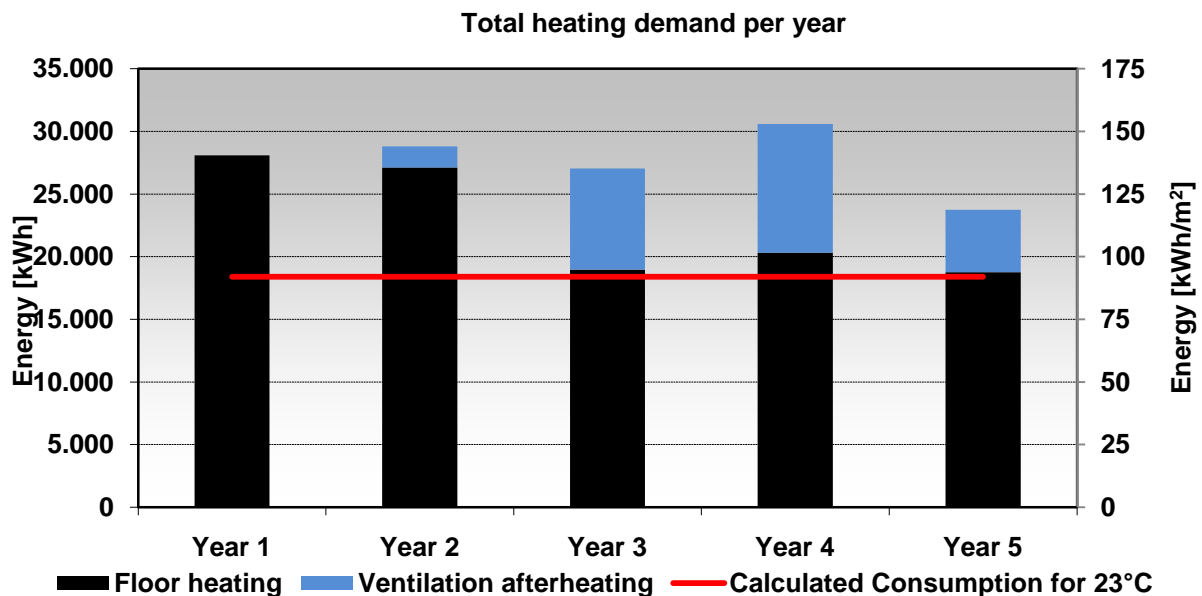
Figure 11 Comparison of heating consumption for each year

As it could be seen from the Figure 11 the energy demand of the floor heating has been more or less identical for last three years. The only thing what has varied is the ventilation energy demand.

Figure 11 shows comparison of the annual heating consumption for each year and the targeted heating consumption.

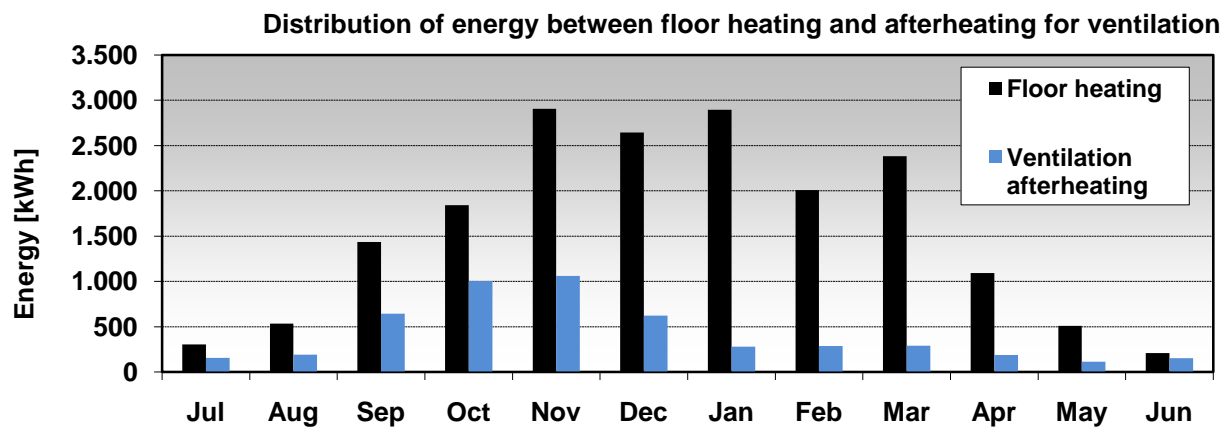
Figure 12 The distribution of heat between the after-heating for ventilation and floor heating

Figure 12 shows how the heat is distributed between the after heating of the ventilation air and floor heating.

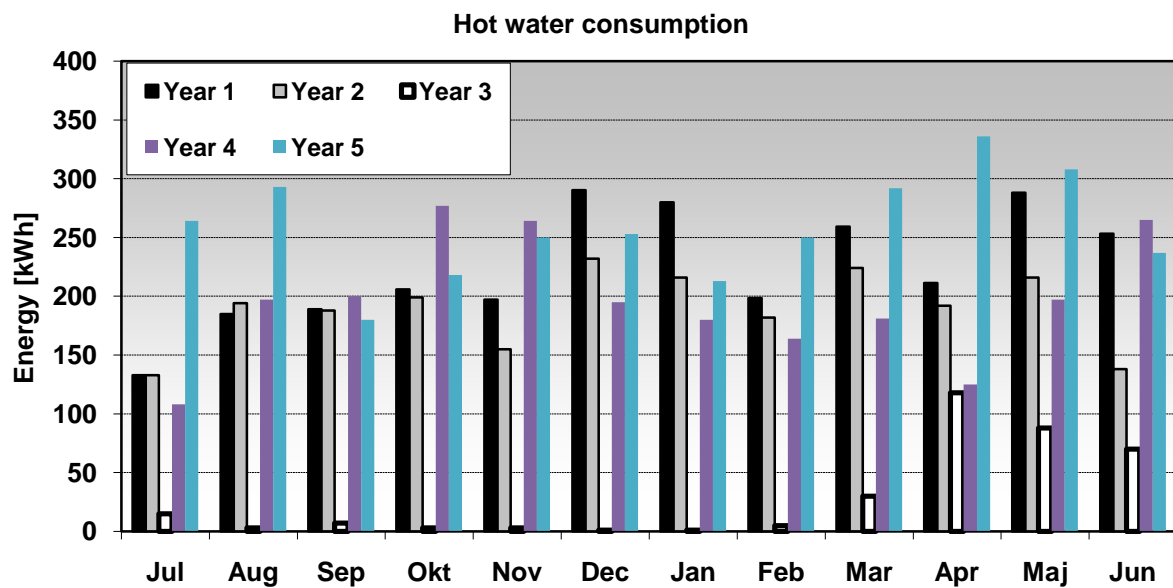
Figure 13 Measured energy consumption for hot water

Figure 13 shows the measured energy needed for domestic hot water.

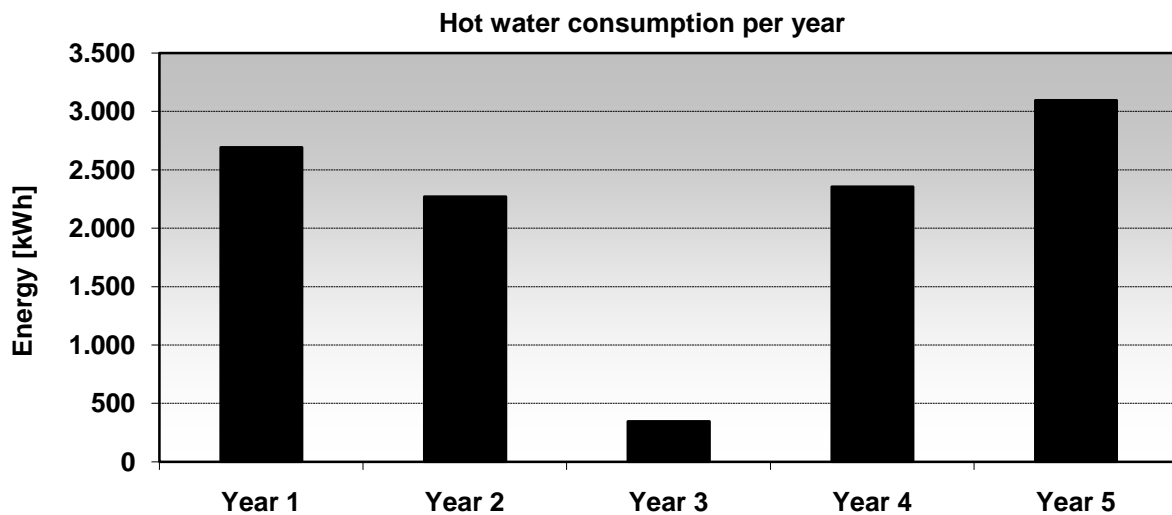
Figure 14 Annual collected energy for hot water

Hot water consumption in year 5 is higher than during previous years which might be caused by higher occupancy of the guest apartment.

Figure 14 shows the annual energy consumption for hot water is obtained from the hot water tank.

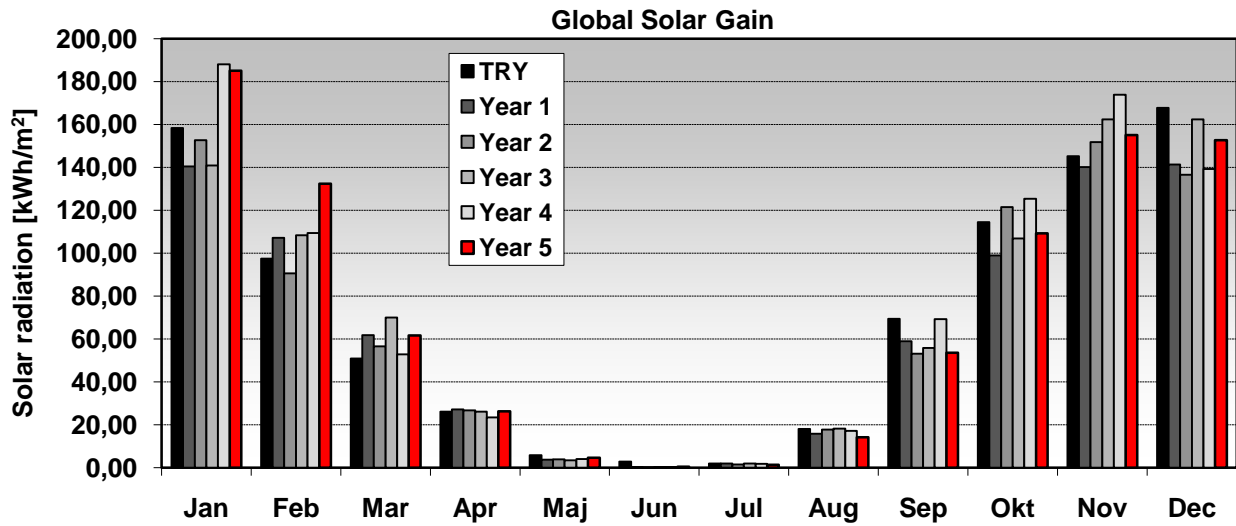
Figure 15 Comparison of reference year and measured global solar radiation

Global solar radiation in year 4 and 5 is nearly the same (904 and 896 kWh/m²) which is about 4% higher than the reference year (860 kWh/m²). It can be seen that the solar gain through the windows (simulated and measured) is not quite the same, but nevertheless in an appropriate level. The reason for the difference between measured and simulated solar gain on vertical surface is partly due to the fact that solar radiation in the reference year has collection of different year variations.

Solar radiation is important both for the solar gain collected by solar panels and for the solar gain received by windows. Figure 15 shows a comparison of monthly global radiation for reference year and for measurement (measured horizontally) made by ASIAQ [7].

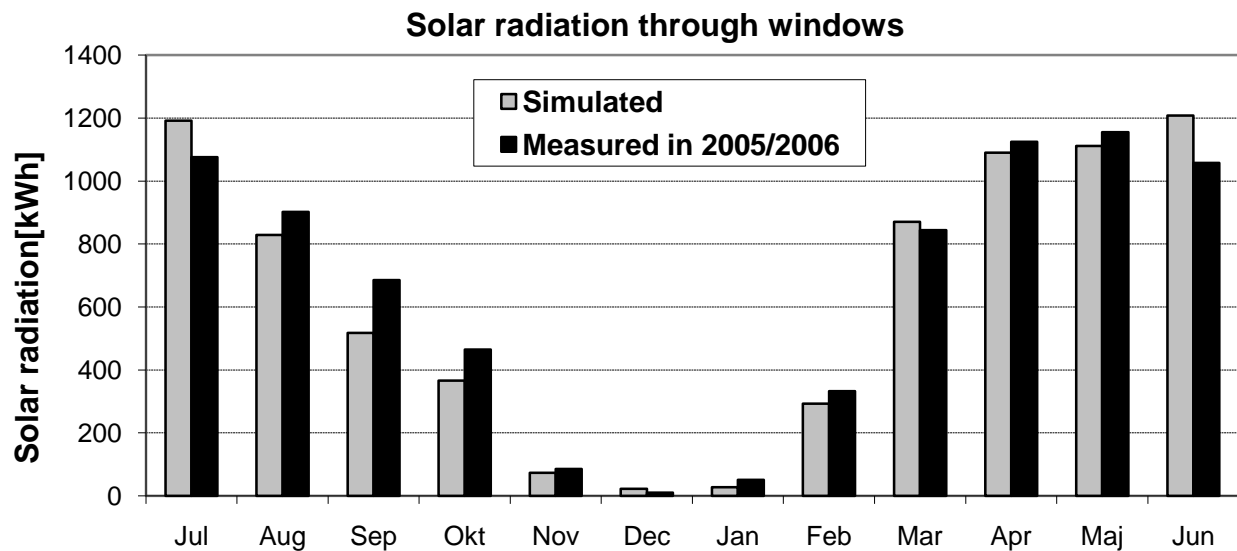
Figure 16 Solar radiation through the windows of the low-energy house

Figure 16 shows the monthly values of radiation on vertical surface for measured values in 2005/2006 and for simulated values (DRY).

The Solhat measurement on vertical surface is not working since the year 2007, therefore the solar radiation on vertical face cannot be calculated for current year (Figure 16).

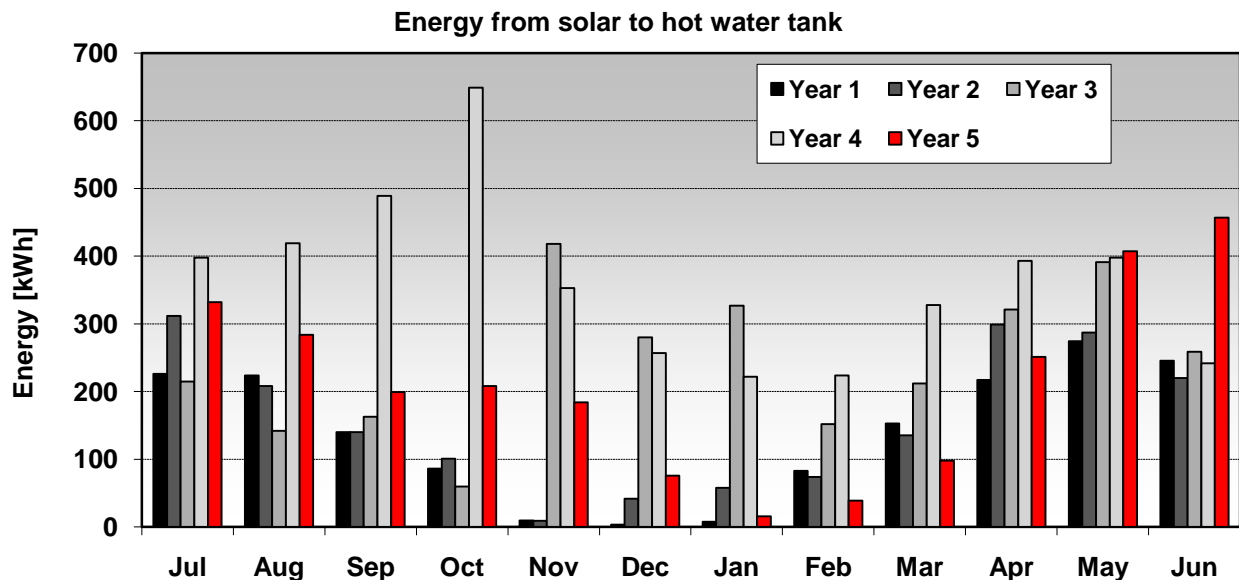
Figure 17 Energy supplied by solar panels for hot water tank

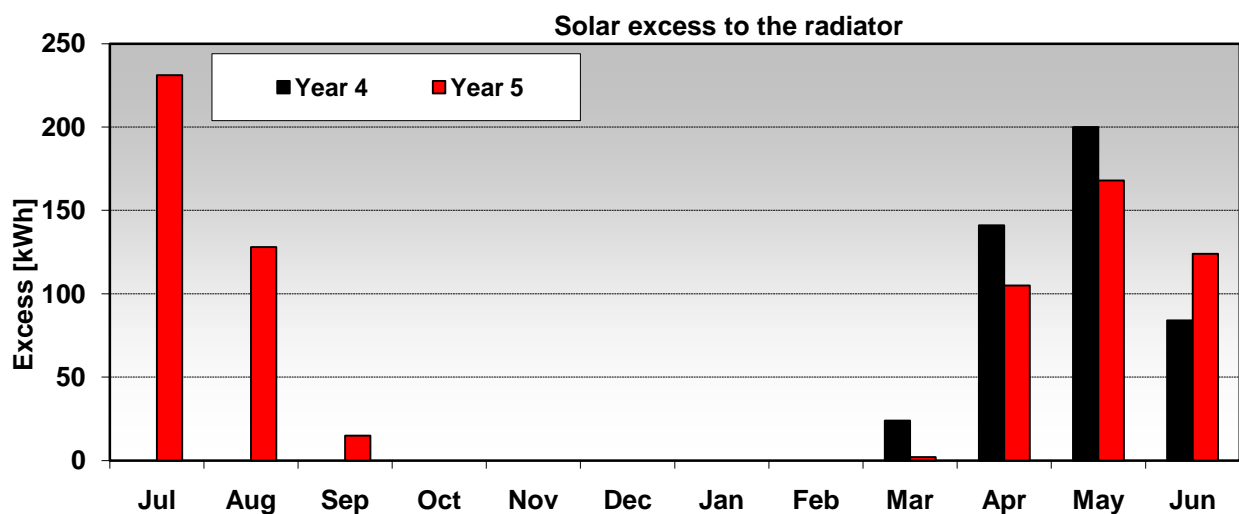
Figure 18 Energy transferred from solar collectors to separate radiator

Besides the solar heat transferred from the solar collectors to the hot water tank, the excess solar heat has been from the spring 2009 also transferred to a separate radiator in the house. In sunny periods where the temperature in the hot water tank is high enough heat is transferred from the solar collectors to the radiator. The energy transferred from the solar collectors to the radiator is shown in Figure 18.

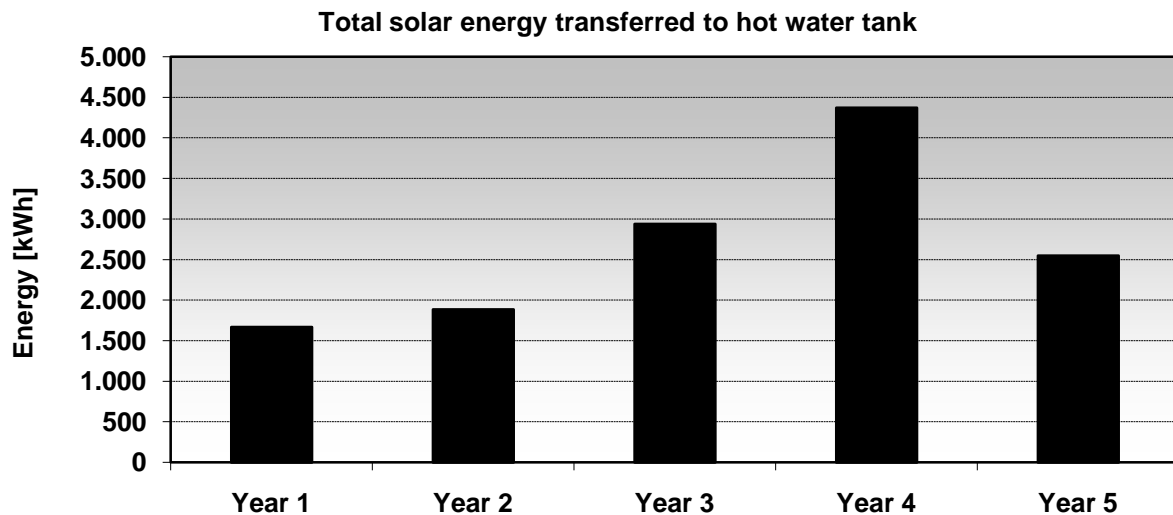
Figure 19 Total annual energy production transferred from the collector to hot water tank

Figure 19 shows the annual energy transferred from collectors to hot water tank.

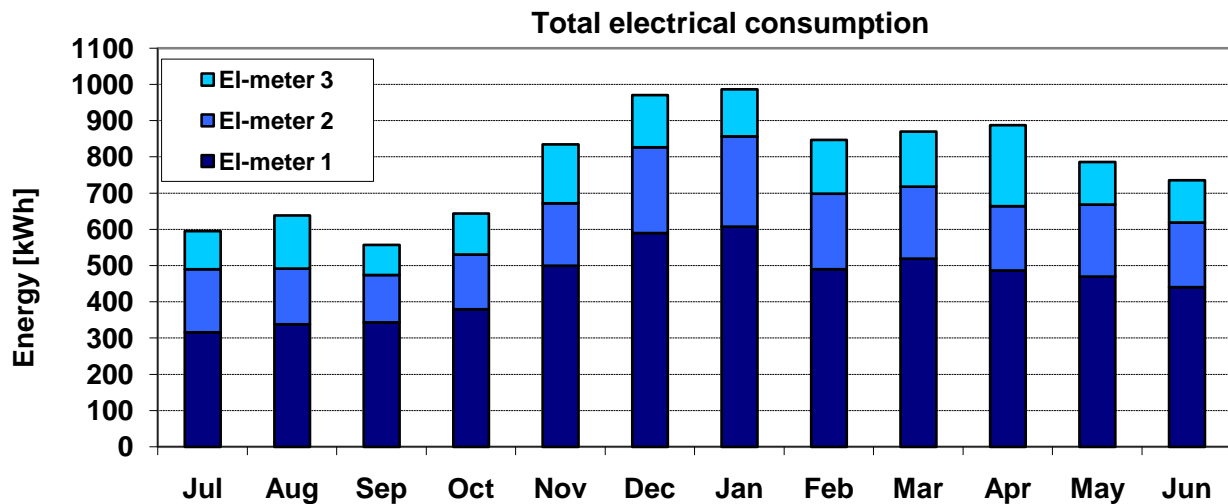
Figure 20 The distribution of electricity consumption throughout the year. El-meter 1 is for the common areas, el-meter 2 is for inhabited apartment and el-meter 3 is for guest part of the house

Figure 20 shows the monthly electricity consumption through the year. The low-energy house has two meters that log consumption in each unit of the house and one electric meter that log consumption in technical room and the other common electrical energy.

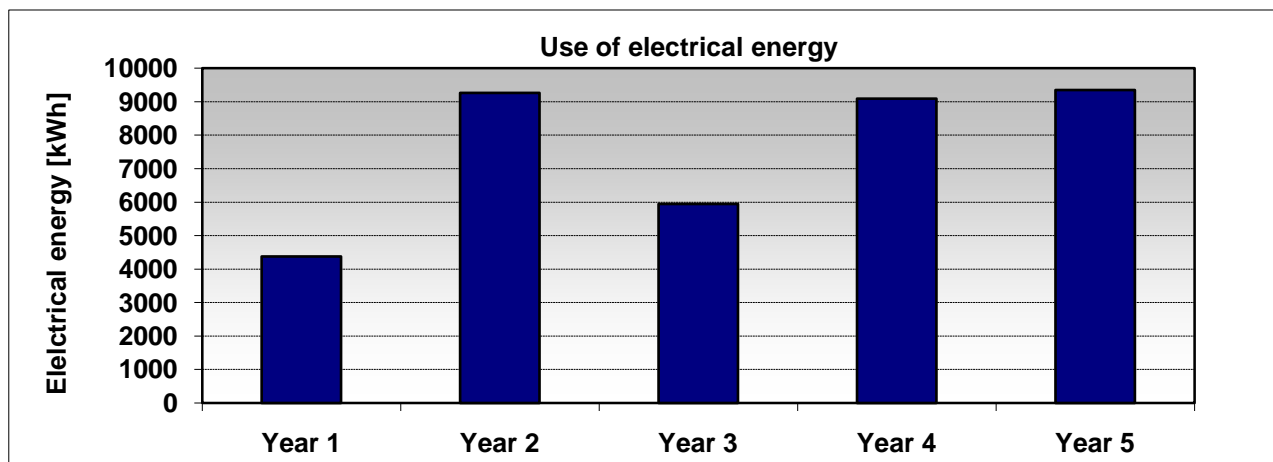
Figure 21 Total yearly electricity consumption

The electricity consumption is almost the same as in the years 2 and 4 when the house was occupied and the frost protection of the sewer pipes was active during winters. It might be expected that the consumption will be decreased by adjusting the ventilation system to operate only when needed.

In Figure 21 the total electricity consumption is presented

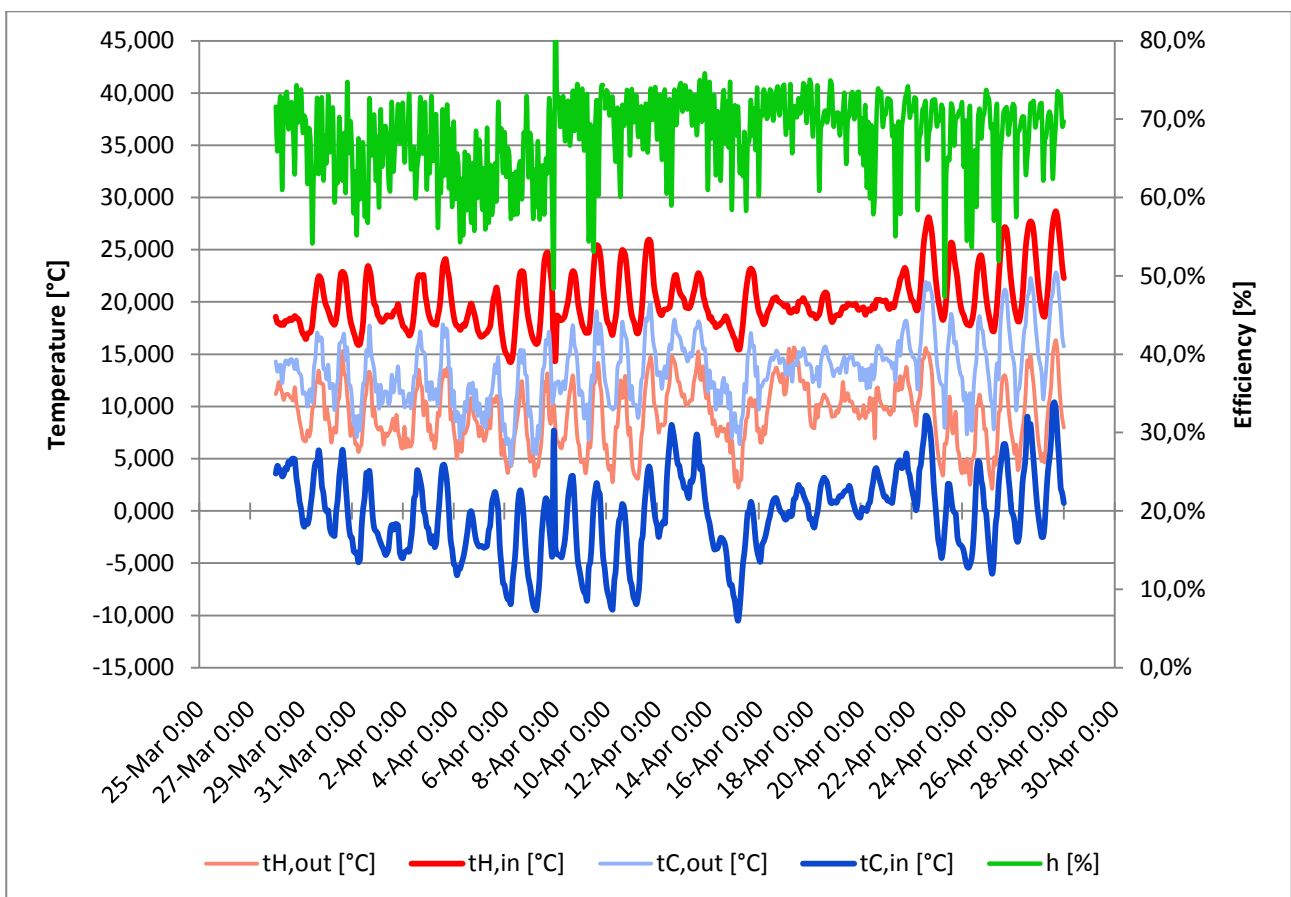
Figure 22 Temperatures and thermal efficiency of the HE

The efficiency of the HE is after fixing the broken damper significantly higher than in previous years but still lower than expected. It might be caused by untightness of the damper or by imbalanced flows as described in [9]. The fact that the air is supplied equally to both apartments even though that the one is almost all year long unoccupied and thus its ventilation is not needed is very surprising. Also the way of air distribution is untraditional, normally the air is supplied to the bed rooms and extracted from the corridors, bathrooms and kitchens but in case of LEH the fresh air is supplied to the corridor and living room and then extracted from bedrooms, bathroom and from kitchen by use of kitchen hood. This setup may cause that the polluted air from kitchen is being sucked through the bed rooms in case of kitchen hood being turned off.

In December 2009 the revision of the HE was made. The revision discovered that the mechanical damper inside the HE was broken. Due to this failure the defrosting function didn't work and therefore there were so many freezing problems with the HE in the past. After fixing the problem the efficiency of the HE has increased. In Figure 22 the temperatures and thermal efficiency of the HE for the period from 28th March 2010 until 28th April 2010 is presented.

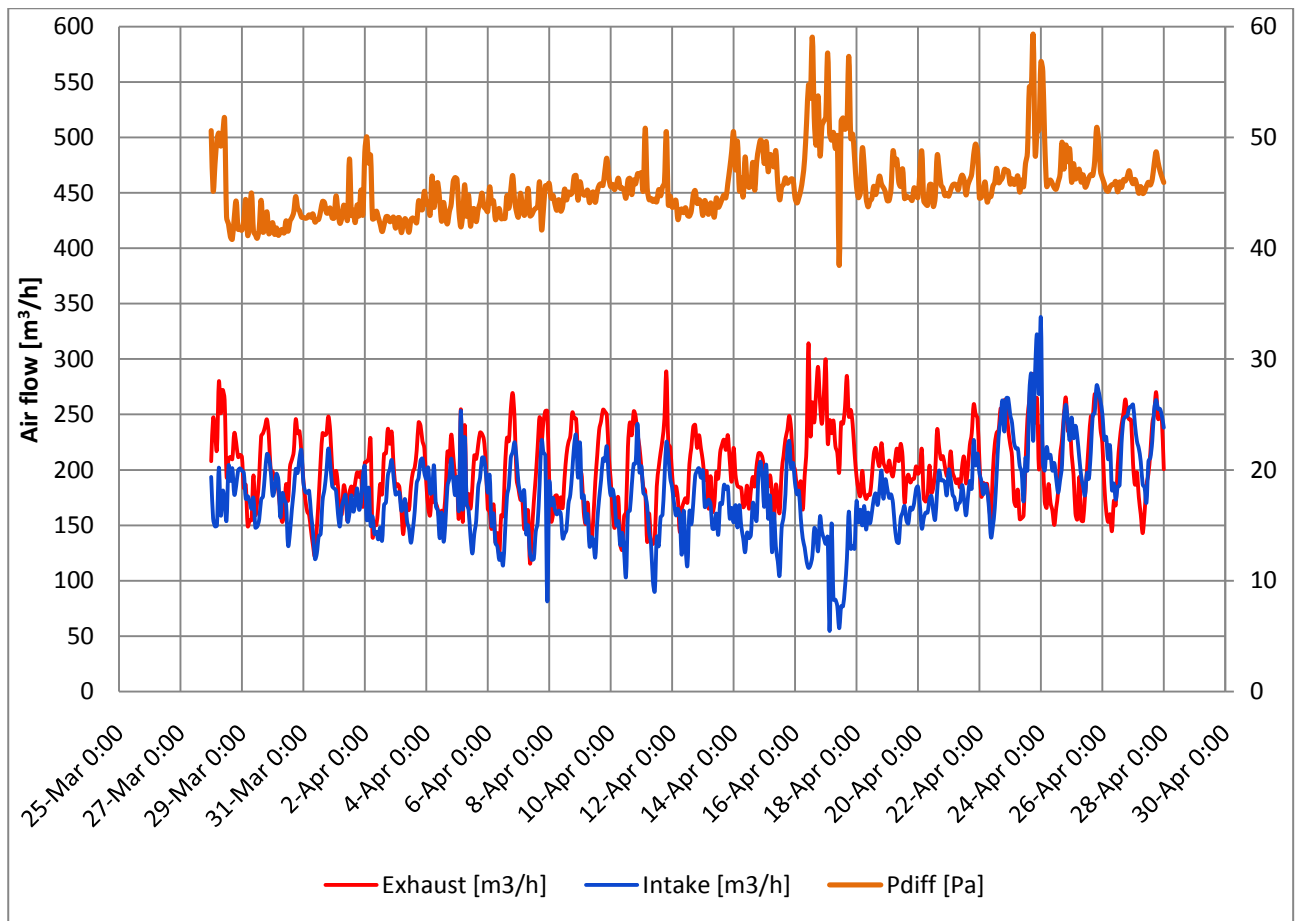
Figure 23 Air flows and pressure loss over the HE on the exhaust side

The air flows and pressure loss on the exhaust side of the HE are presented in Figure 23.

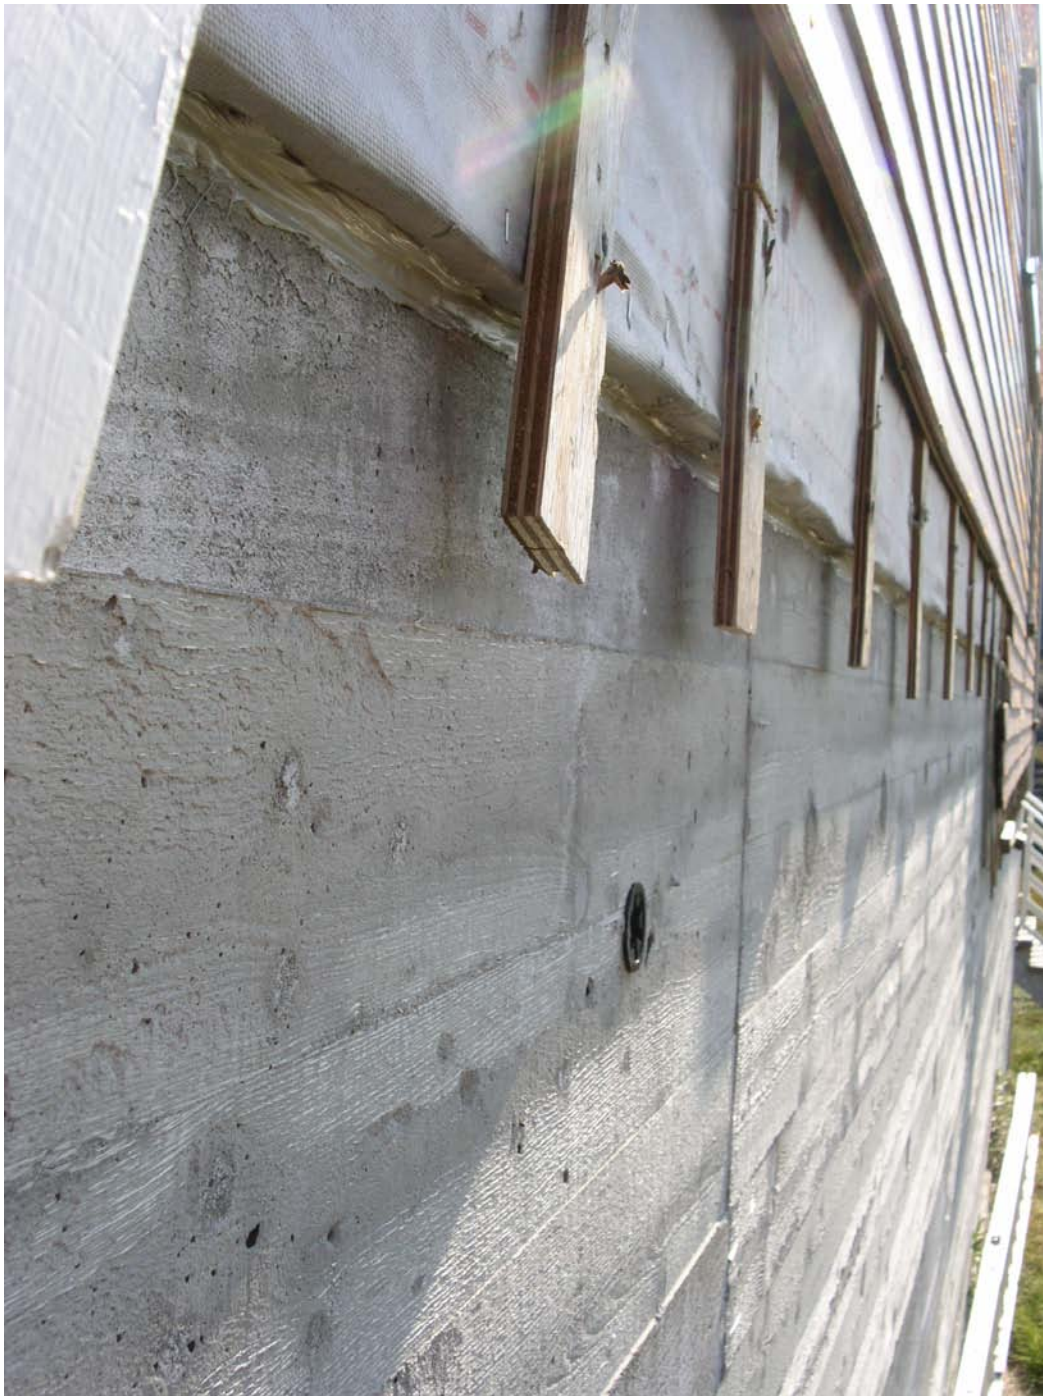
Improving the air tightness (summer 2010). The gap between wind barrier and wall has been sealed by silicon

During the summer 2010 the wooden cladding on the façade was partly removed and the leakages of the wind barrier by the windows and corners were sealed after the cladding was back in place the new paint was applied on the entire outer surface. It is expected that the air tightness has been improved which will be tested by the blower-door test.

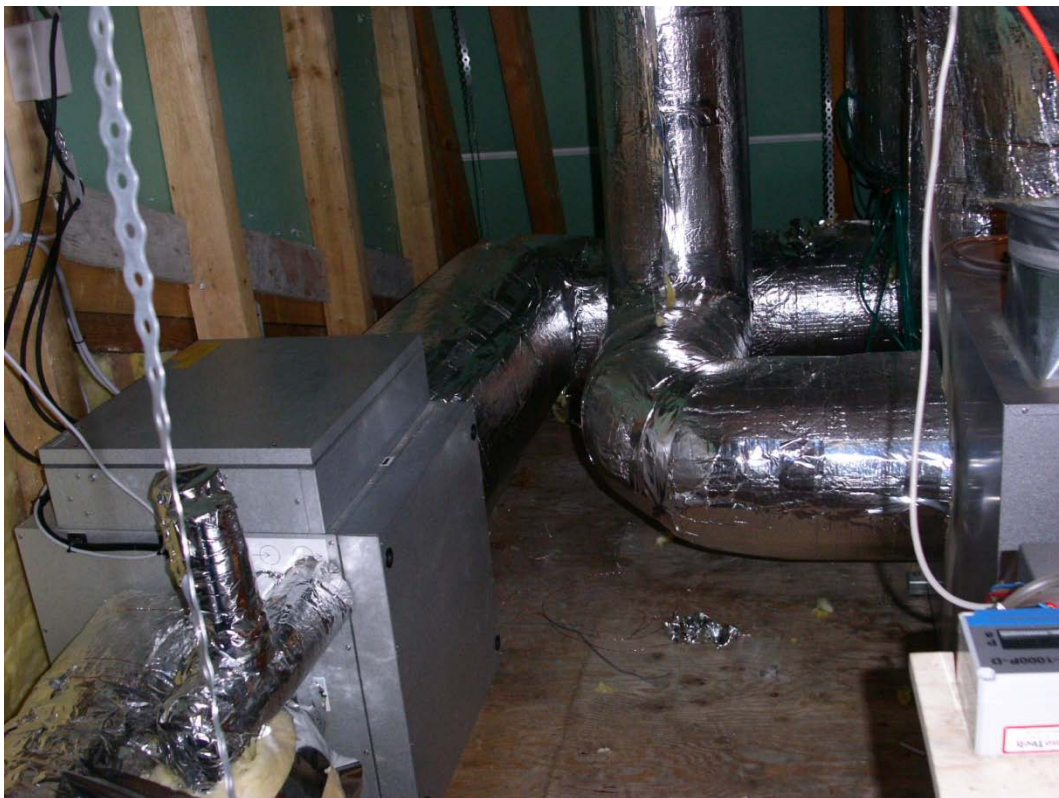
Insulated ducts and the additional heating coil.

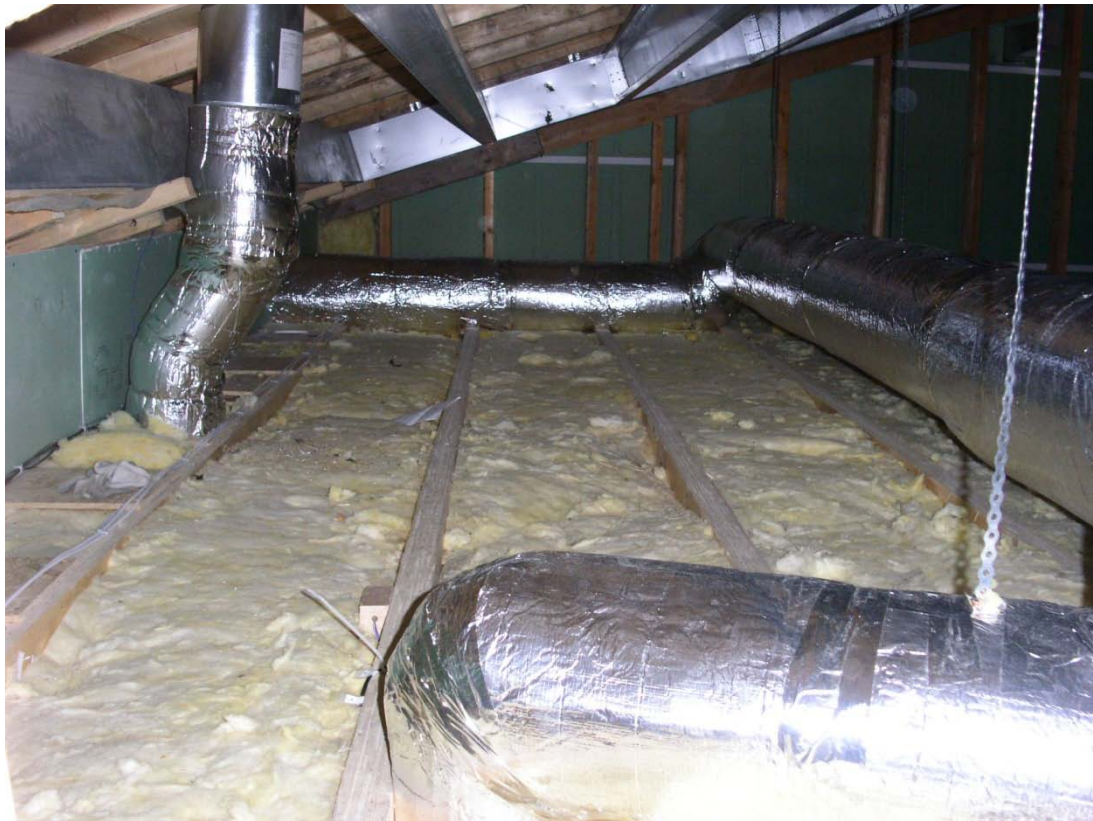
Insulated ducts in the cold attic.

During December 2009 the extra insulation was put on ventilation ducts

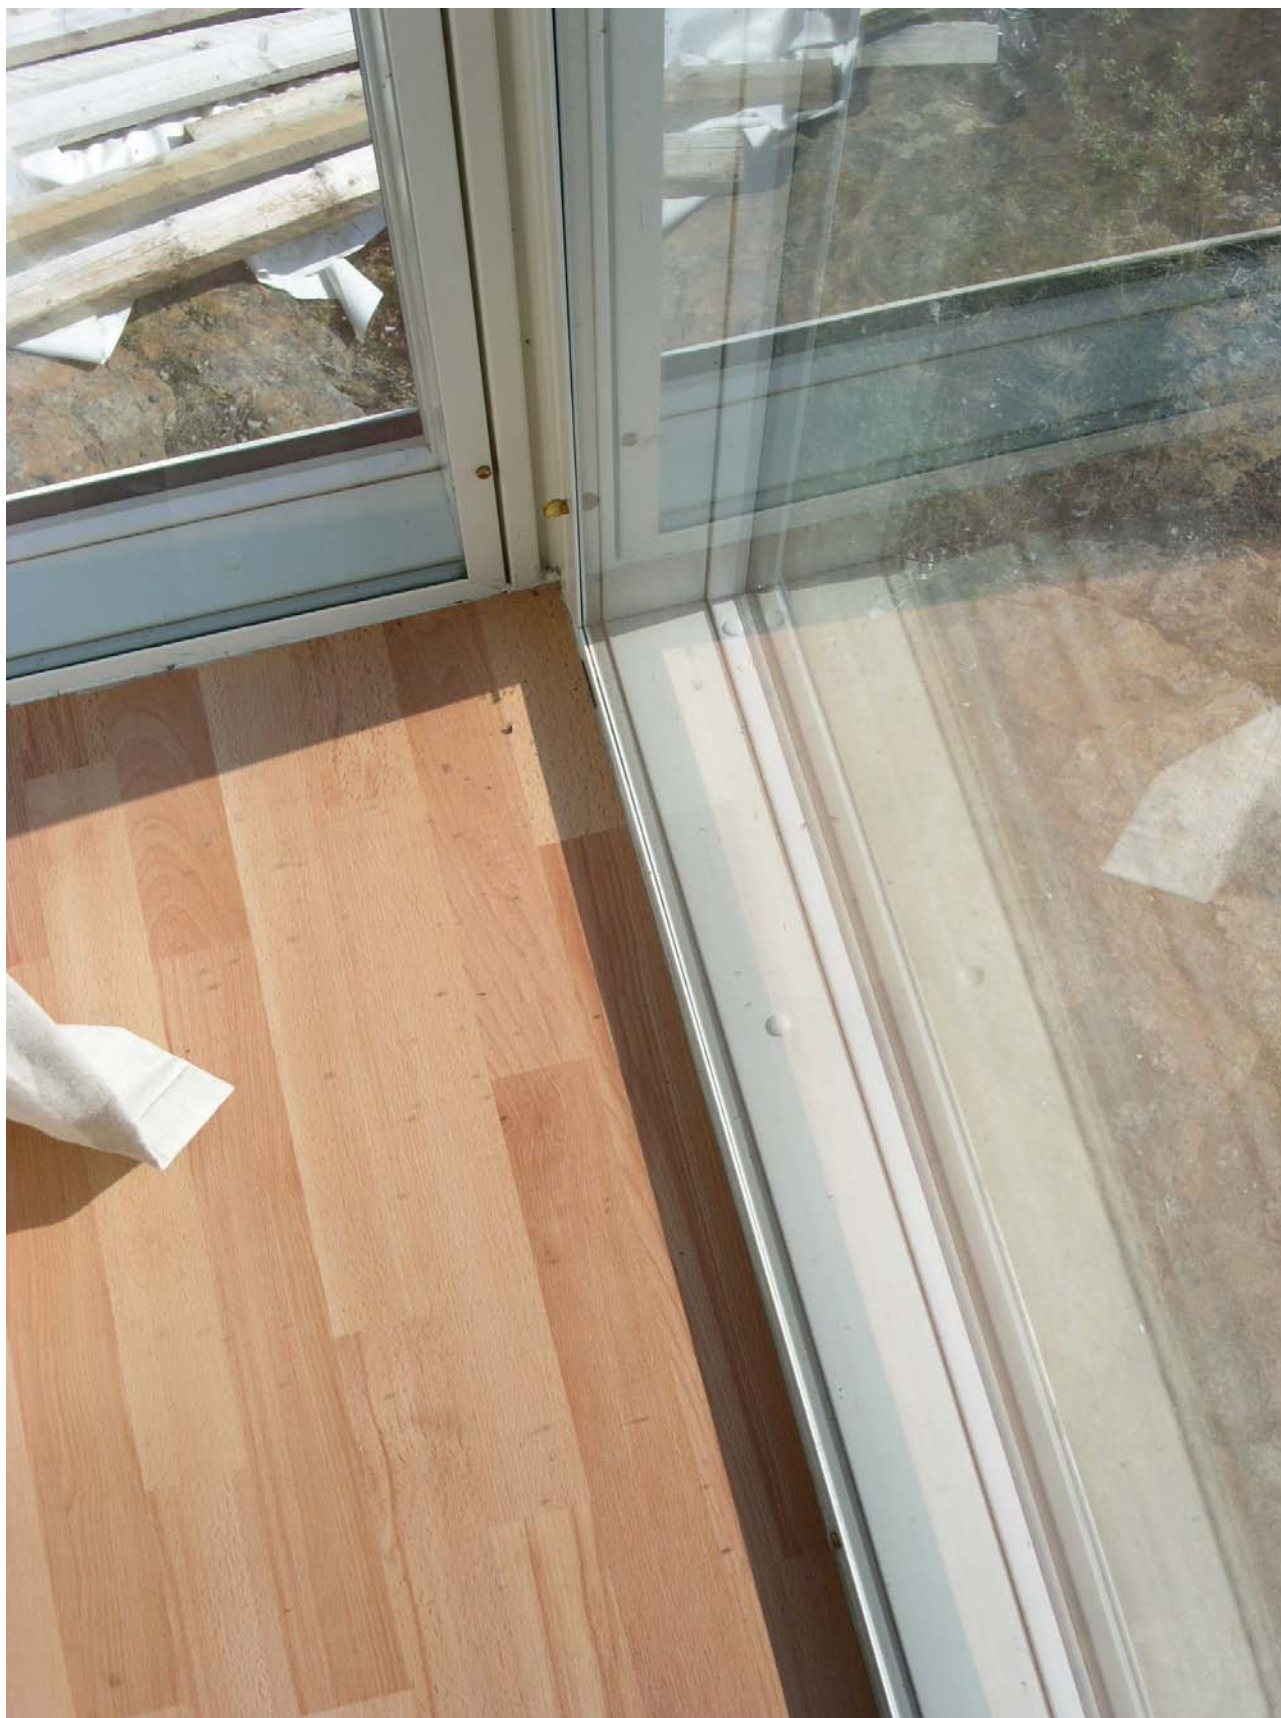
Sealed holes in the window frames.

July 2010	The cracks in the paving were sealed
July 2010	Large holes in the window frames which were drilled before in order to ventilate the windows were sealed now because the holes were found to be too large
